PUBLIC ROADS

A JOURNAL OF HIGHWAY RESEARCH

Page
Illustrations of Frost and Ice Phenomena	61
Progress Report of the Connecticut Avenue Experimental Road	69
Some Points of Contact Between Soil Science and Highway Engineering	77

ILLUSTRATIONS OF FROST AND ICE PHENOMENA

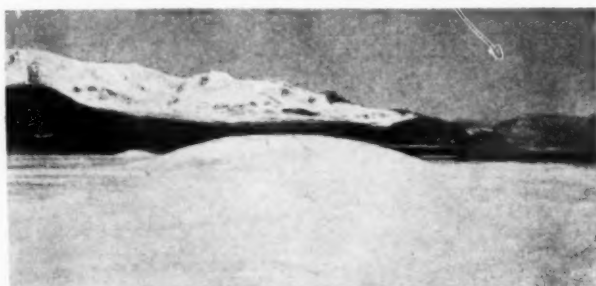
FIGURE 4.—AN ICE HEAVE OR MOUND COMMON ON FROZEN RIVERS IN ALASKA (PHOTO BY U. S. G. S.)

Figures 4 and 5 illustrate ice mounds familiar to those who travel in polar and subpolar regions when the rivers are frozen. The occurrence of these mounds is explained as follows:

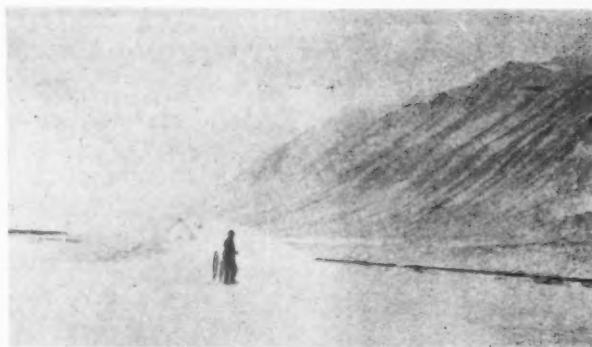
FIGURE 5.—SHOWING THE RELATIVE HEIGHT OF AN ICE HEAVE OR MOUND ON A FROZEN RIVER IN ALASKA. (PHOTO BY U. S. G. S.)

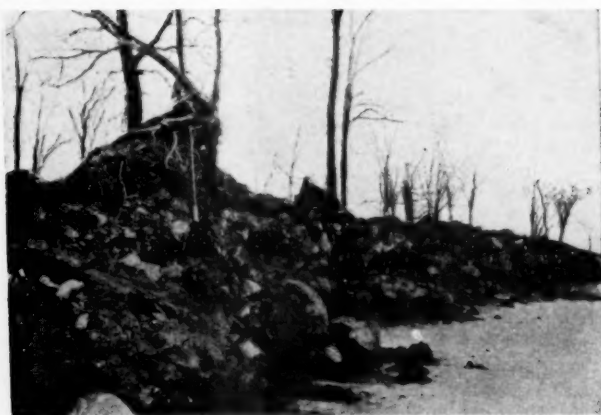
FIGURE 6.—THE RESULT OF ICE THRUSTS ON PICNIC POINT NEAR MADISON, WIS. (PHOTO BY DOCTOR E. R. BUCKLEY)

Figure 6 shows a bank of soil composed of sod, boulders and clay which, according to Doctor Buckley (9), was thrown up during the winter of 1898-99 by ice thrust on the edge of a lake in Wisconsin. The average dimensions of this bank were a height of about 4 feet, a breadth of base of about 11 feet, and a breadth of top

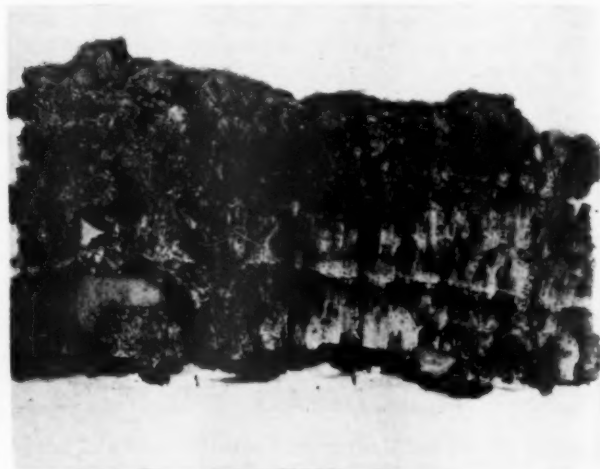
FIGURE 8.—SHOWING THREE STAGES OF GROWTH OF ICE CRYSTALS FORMED ON THE SURFACE OF WET CLAY DURING THREE CONSECUTIVE NIGHTS OF FREEZING TEMPERATURE WITH LITTLE OR NO THAWING DURING THE INTERVENING DAYS

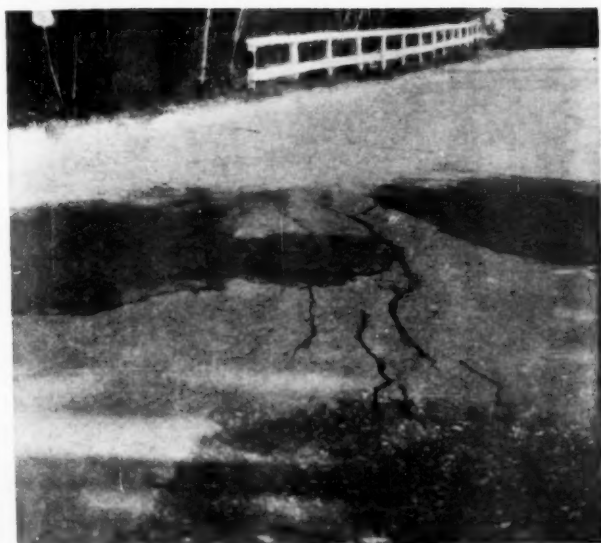
FIGURE 9.—A FROST BOIL IN A SURFACE-TREATED MACADAM LAID ON BED OF SILT. THE HEAVE WAS DUE TO A LEAKING WATER PIPE BENEATH FOLLOWED BY FREEZING

Figure 9 shows the surface appearance of a "frost boil" under a surface-treated macadam road in New Hampshire. The origin of the water in the boil was traced to a leaking water pipe beneath the subgrade. The type of soil was a fine silt which served as a water pocket. Whether this heaving was produced by solid ice or by ice crystals which had become more or less segregated from the soil by frost action is not known. It seems probable, however, that much if not all of this heaving was due largely to a mixture of ice and soil of a form somewhat like that shown in Figure 8.

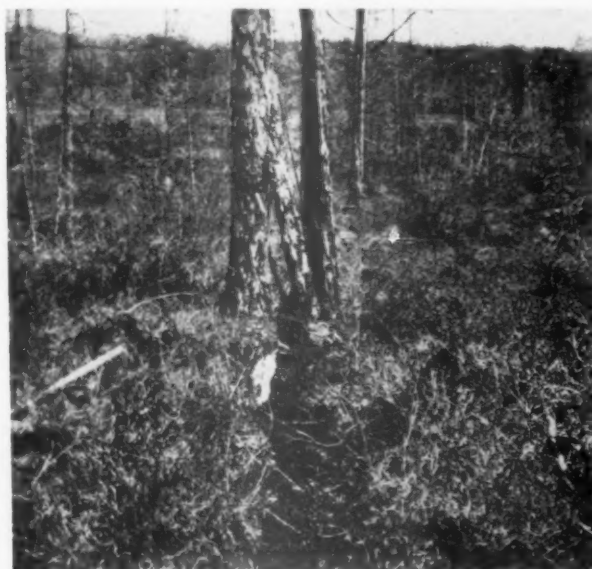
FIGURE 13.—TAMARACK TREE ON THE SUMMIT OF A BLISTER, SPLIT WHEN THE BLISTER BROKE

surface soil, the supercooled water is forced through the crack and is probably frozen instantly. Figure 13 shows a tree split by a fissure occurring on the summit of an ice blister.

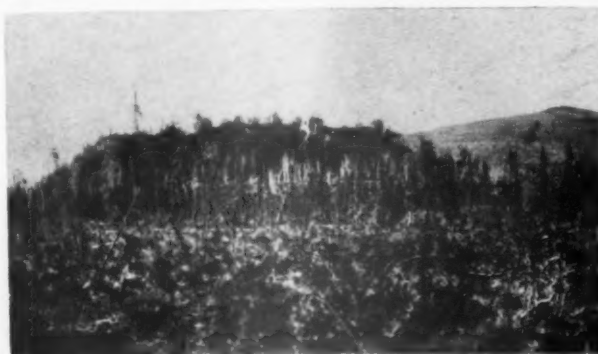
FIGURE 14.—A MOUND FORMED OF MUD AND GRAVEL BELIEVED TO HAVE FORMED FROM SPRINGS SUBJECTED TO FROST ACTION. (PHOTO BY U. S. G. S.)

Figure 14 illustrates similar mounds formed of more or less segregated fragments and particles of alluvial materials believed to be of Pleistocene or recent age observed by Leffingwell (12) and others in Alaska. Most of these mounds are in the form of gentle domes ranging in height from less than 25 feet to a maximum of about 200 feet above the plain. Generally they have rounded tops and slopes of less than 15° from the horizontal but a very few are steep-sided and have an angular break at a somewhat level top. Some of the more recent mounds contain craters which furnish fresh water to such extent during the summer that they may overflow.

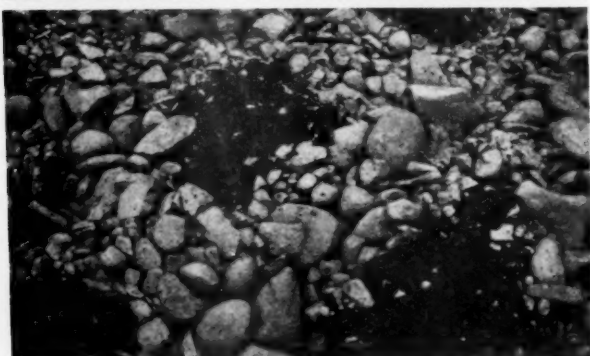
FIGURE 15.—A FROST-HEAVE AREA AT THE FOOT OF A SLOPE IN THE LAKE CLARK-KUSKOKWIM REGION, ALASKA, AND A CLOSE UP OF ONE OF THE FROST HEAVES. (PHOTOS BY U. S. G. S.)

Figure 15 (upper picture) shows a frost-heave area in the foreground at the foot of a slope in Alaska. These mounds, while small in comparison to some of those just described, seem to occur under conditions more or less similar to those productive of the larger ones. Where the development has progressed beyond the youthful stage these frost boils are invariably largely made up of

Figure 15 (lower picture) is a close-up view of one of these heaves. While geologists do not seem to be in full accord as to the exact manner in which this segregation of the finer particles from the larger rock fragments occurs, they are agreed that in all cases these mounds occur only where the ground is more or less thoroughly saturated with water and is subjected to conditions of alternate freezing and thawing of the surface layers of the ground (8, 13).

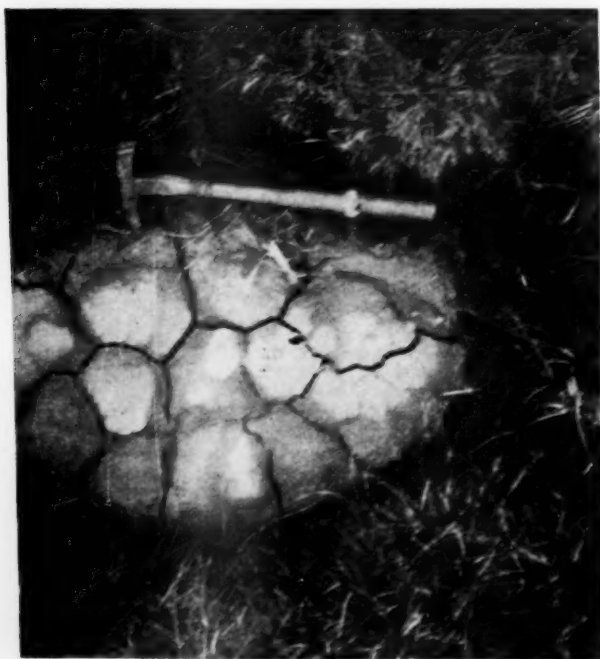
FIGURE 16.—A DRIED AND CRACKED MUD BOIL FOUND IN ALASKA BY EAKIN. (PHOTO BY U. S. G. S.)

Figure 16 shows the appearance of a dried and cracked mud boil found in Alaska by Eakin (7), which probably originated under the type of frost action just described.

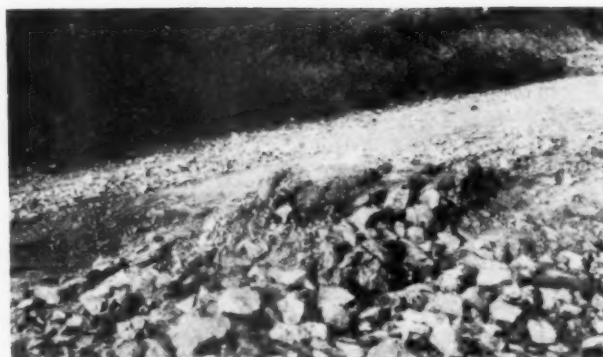
FIGURE 17.—A MUD BOIL IN A WATER-BOUND MACADAM LAID ON A FINE SANDY CLAY SOIL

The only difference between frost and mud boils is the manner in which the water accumulates. In reality discharging frost boils are nothing more than mud boils formed under frost action. Figure 17 shows a mud boil found about the middle of summer in the District of Columbia on the surface of a water-bound macadam laid on a fine sandy clay soil. This mud boil originated from a leaking water pipe and is similar in detail to the frost boils already described. It was first observed as a small mud-filled fissure on the road surface. With each passing load an eruption occurred and the volume of mud and water at the surface increased until a considerable mound was formed. Such boils may occur in any region where very fine particles of soil become reduced to the liquid state and under pressure the viscous fluid is extruded through fissures or other openings of such size as will permit its passage.

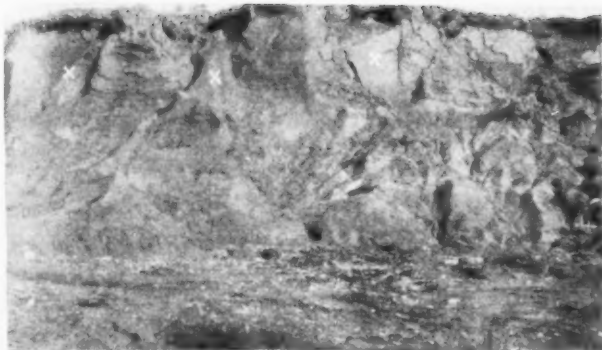
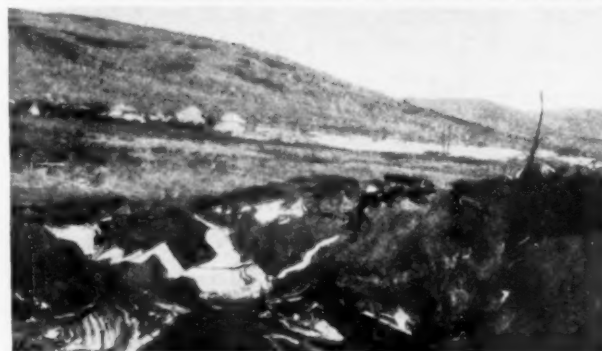
FIGURE 19.—ICE WEDGES IN FROZEN SOIL IN ALASKA.
(PHOTO BY U. S. G. S.)

Figure 19 illustrates ice wedges shown by X which are apt to form due to the cracking described above. The snow which fills the newly formed fissures soon becomes compacted and may reach a density equal to that of solid ice under conditions of alternate freezing and thawing such as frequently occur toward the end of the polar winters.

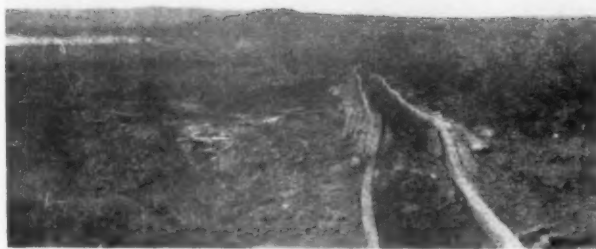
FIGURE 21.—EFFECT OF HEAVE AND THRUST ON THE POSITION OF A TRAM LINE IN ALASKA. (PHOTO BY U. S. G. S.)

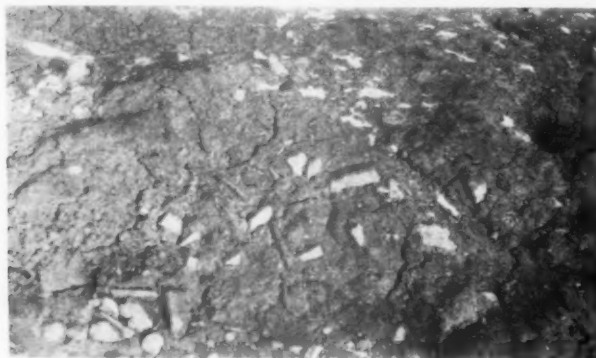
FIGURE 22.—SHRINKAGE FISSURES IN FROZEN CLAY SOIL IN THE DISTRICT OF COLUMBIA

Figure 22 illustrates fissures observed in frozen clay soil in the District of Columbia. Similar fissures ranging in width from one-eighth to one-fourth of an inch were observed also in Minnesota. In both cases the fissures contained hoar frost, but no ice crystals were observed. Hoar frost is always derived from water vapor but ice crystals such as those shown in Figure 8 are always formed from unfrozen moisture at the base of the crystals.

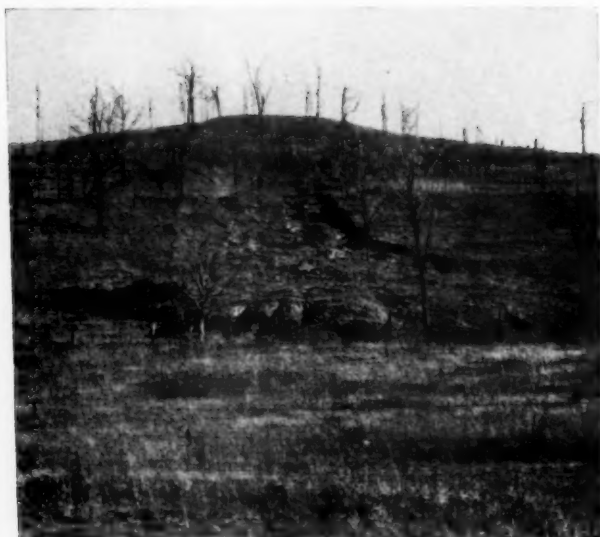
FIGURE 23.—AN AVALANCHE OF MUD, SOIL, AND ROCKS WHICH HAS SLID DOWN A HILLSIDE OF SHALEY SOIL

Figure 23 illustrates the type of soil migration which may occur when snowfall is heavy and frost penetrates the ground to an appreciable depth.

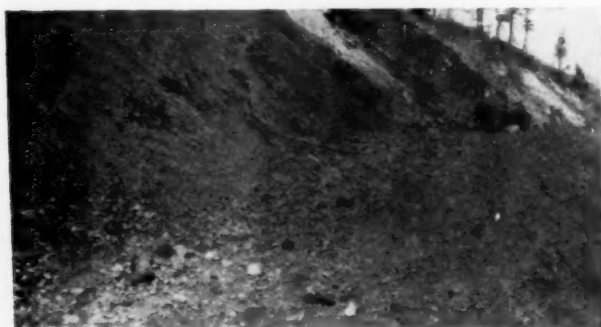
FIGURE 24.—EFFECT OF FROST ON SOIL MIGRATION WHERE THE PARTICLES RANGE FROM FINE TO COARSE AND ARE NOT COMPACT IN ARRANGEMENT

Figure 24 shows the type of soil migration from the face of cuts in porous soils after frost action.

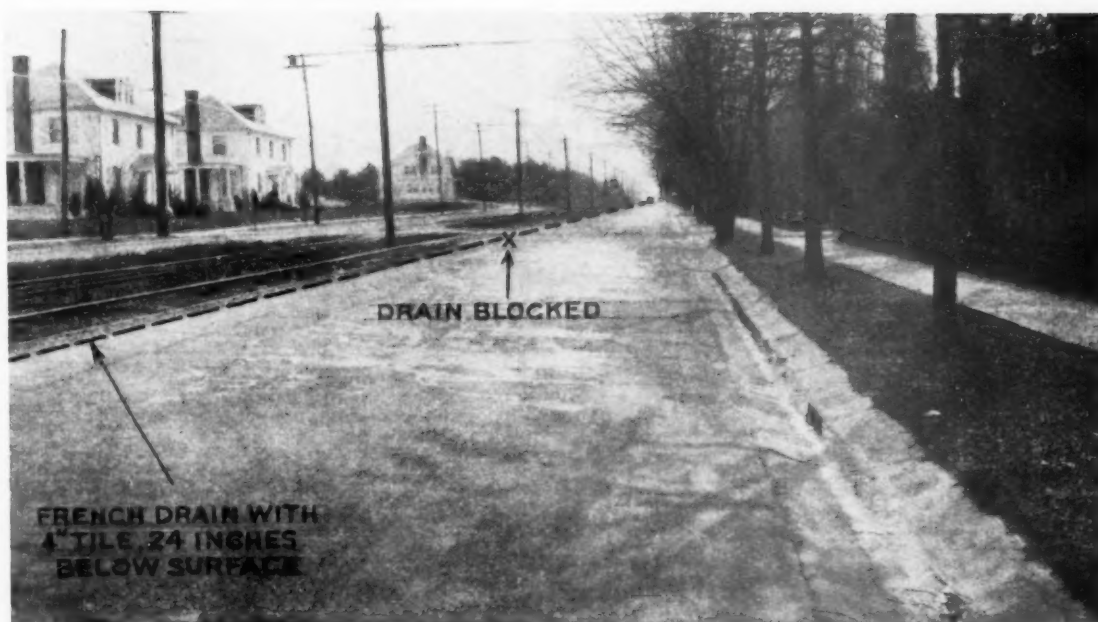
FIGURE 4.—SECTION 3, NORTH OF BRADLEY LANE, FEBRUARY, 1929. APPEARANCE OF SECTION JUST NORTH OF VIRGILIA STREET. SHINY AREAS ARE WATER WHICH HAS COME UP THROUGH THE CRACKS IN THE CONCRETE PAVEMENT. NOTE WATER WHICH HAS FLOWED FROM THE SURFACE INTO THE GUTTER AT THE RIGHT

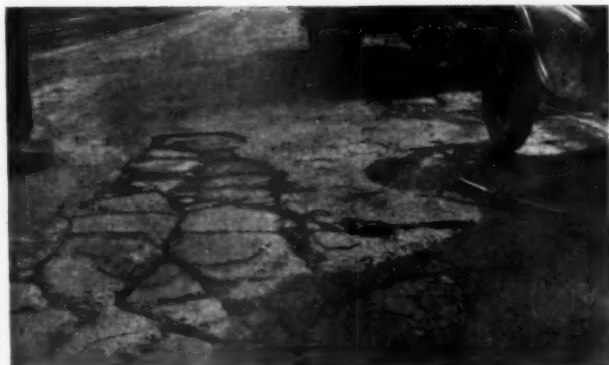
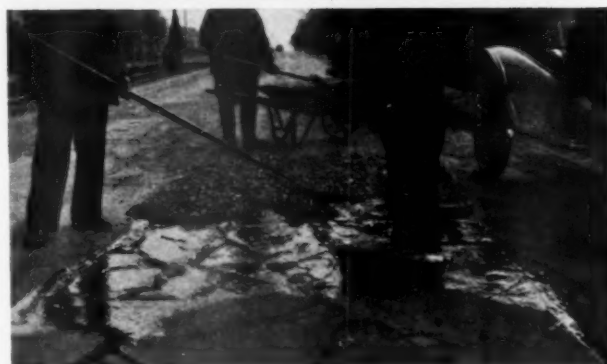
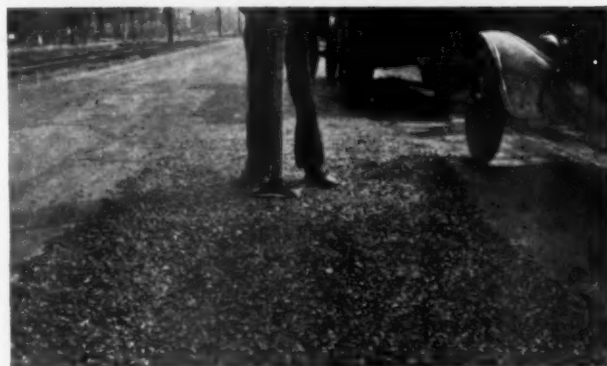
FIGURE 6.—METHOD OF MAKING REPAIRS ON THE CONCRETE SECTIONS IN THE BADLY CRACKED AREAS
